MATERIALS AND RESEARCH DEPARTMENT
5900 FOLSOM BLVD., SACRAMENTO 95819

November 1970
M&R No. 636405-3
Final ReportMr. J. A. Legarra
State Highway Engineer

DYNAMIC TESTS OF AN
ENERGY ABSORBING BARRIER EMPLOYING
WATER-FILLED CELLS

SERIES XXI

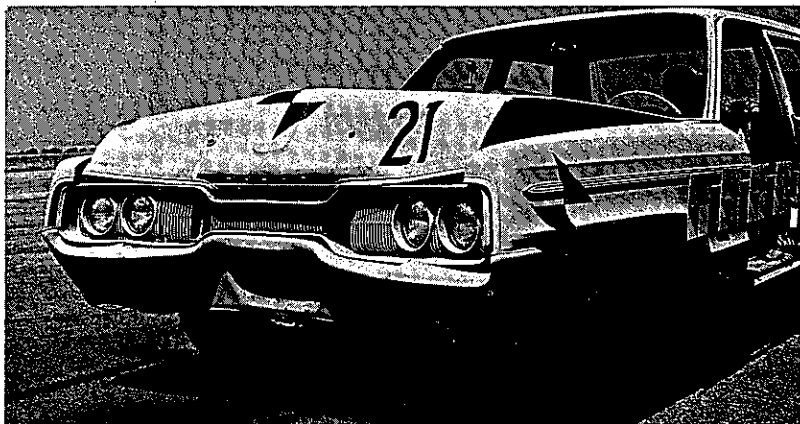
Figure 2

Results: See Plate 2 (page 14) for a summary of the test results. A 4680 lb. Dodge impacted the test barrier headon at a speed of 33.3 mph. The test vehicle did not stop quite as smoothly as it did for Test 211. Vehicle rise was 4-1/2 inches. Damage to the vehicle was moderate and included deformation of the grill, front bumper, and front of the hood (see Figure 2, below). The exhaust manifold was broken near its attachment to the engine block and the radiator was forced back into the V-belt lower pulley. The post behind the front door (removed for the test) on the drivers side failed at its connection with the roof (see Figure 3, below). The permanent deformation of the steering wheel was 2" (see Figure 4, below).

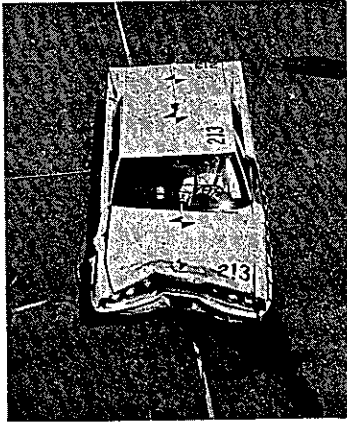
Figure 7

Results: See Plate 3 (page 18) for a summary of the test results. A 4600 lb. Dodge impacted the test barrier headon at a speed of 48.2 mph. During impact, the vehicle rode up on the barrier nose. Vehicle rise was 11 inches. The vehicle fan and radiator were jammed up against the engine block. There was severe damage sustained by the grill, front bumper, and front of the hood of the test vehicle (see Figure 7, below). The body of the vehicle was deformed over the door post and in front of the front door hinges on both sides, indicating a severe buckling failure of the vehicle chassis (see Figure 8, below). There was severe buckling of the right front fender

and minor buckling of the left front fender. There was moderate buckling of the floor board in the rear of the passenger compartment. The impact force of the dummy, restrained by both a lap belt and single diagonal shoulder harness, caused a 2-1/2 inch permanent deformation in the steering wheel. The driver's seat came loose on its guides although the guides remained firmly attached to the floorboard. There was some fraying of the shoulder harness near its connection to the lap belt. The vehicle was considered a total loss.

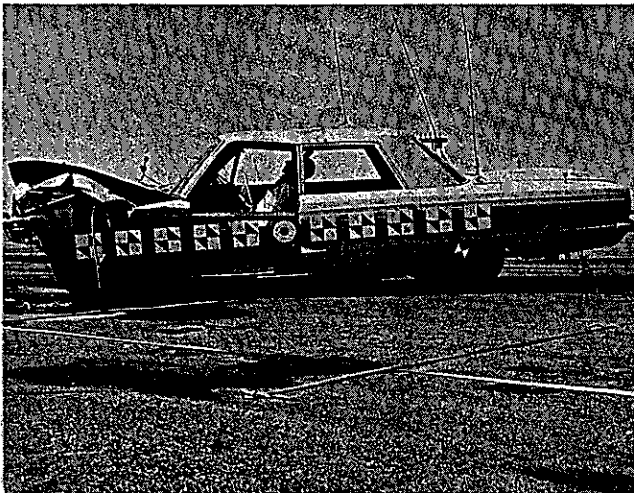
Figure 11

The following vehicular damage was sustained. The fan and radiator were jammed up against the front of the engine block, which appeared to be displaced slightly to the rear. There was severe damage to the grill, front bumper, and front of the hood of the test vehicle. The body of the vehicle buckled over the door posts and in front of the front door hinges on both sides, indicating severe buckling of the vehicle chassis. There was severe buckling of the left front fender and minor buckling of the right front fender. Maximum deformation of the front of the vehicle was 2 ft. (see Figure 11, below). There was some displacement of the dashboard into the passenger compartment and 4-1/2 inches of steering column projection into the passenger compartment. The impact force of the dummy caused a 3-3/4 inch permanent deformation in the steering wheel (see Figure 12, below). Stitching of the diagonal shoulder harness frayed near the connection of the shoulder harness to the lap belt.

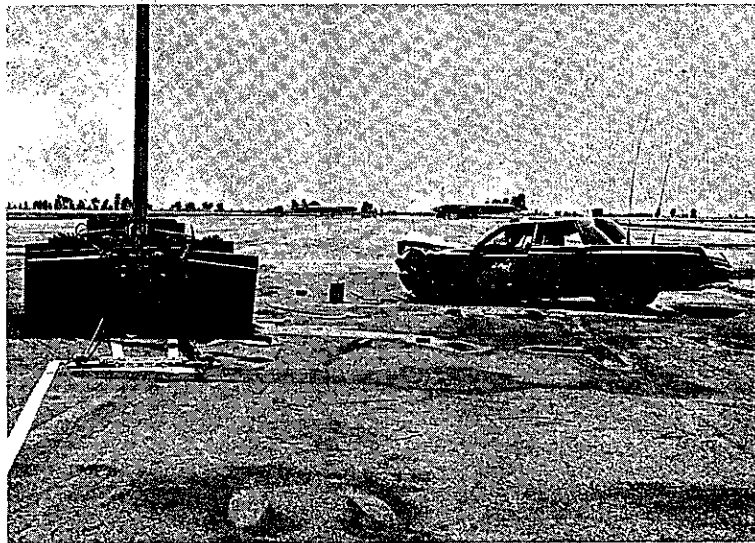
Figure 21

Results: See Plate 6, page 31, for a summary of the test results. A 1968 Dodge impacted the barrier headon at a speed of 57.5 mph. As rearward displacement of the barrier began, the fender panels rotated downward such that their lower rear corners penetrated into the asphalt concrete runway and restricted backward movement of the barrier. This, plus an 18 inch vehicle offset at impact, resulted in a lifting, rolling motion being imparted to the test vehicle. The vehicle traversed a 360° roll off to the right side of the barrier and came to rest several feet behind and to the right of the barrier (see Figure 21, below). Front end crush varied from 0 to 20 inches; maximum crush was on the left side (see Exhibit 8). The top caved in, the windshield was broken, the left rear wheel was bent, the left rear door jammed, and there were scrapes over much of the surface of the vehicle. However, off-center impacts on any barrier nose may inherently cause this type of vehicle instability due to the unsymmetrical rise of the vehicle fore-structure. There was no measurable deflection of the collapsible steering column.

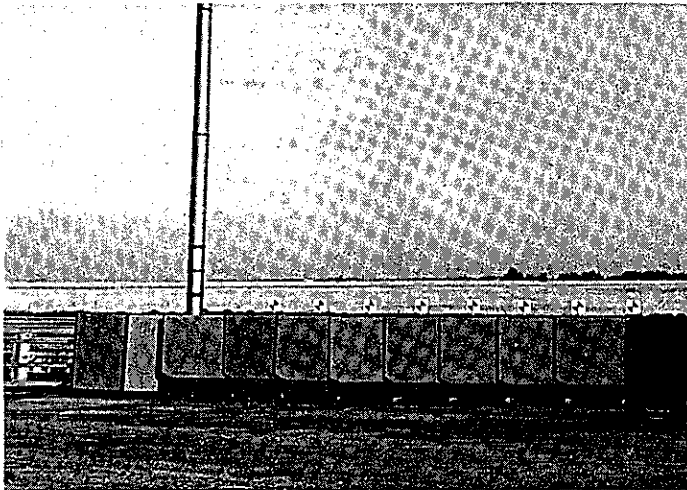
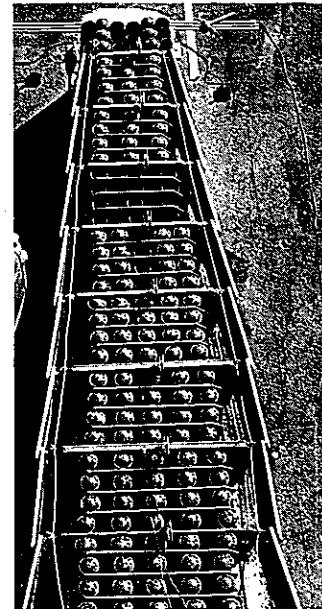
Barrier Description: Modifications to the barrier used for Test 215 included cutting off the lower six inches of all the fender panels and cutting the lower rear corner of the panels on a diagonal to eliminate penetration of these trailing corners into the runway as occurred during Test 215 (see Figures 24 and 25, below). Also, metallic shoes (or skids) were added to the lower edge of interior panels, heavier hinges were used to attach the fender panels to the diaphragms, and all the evaporation flaps were removed to lessen, at least to some extent, the lateral discharge of the water and danger of loss of telemetry signal.

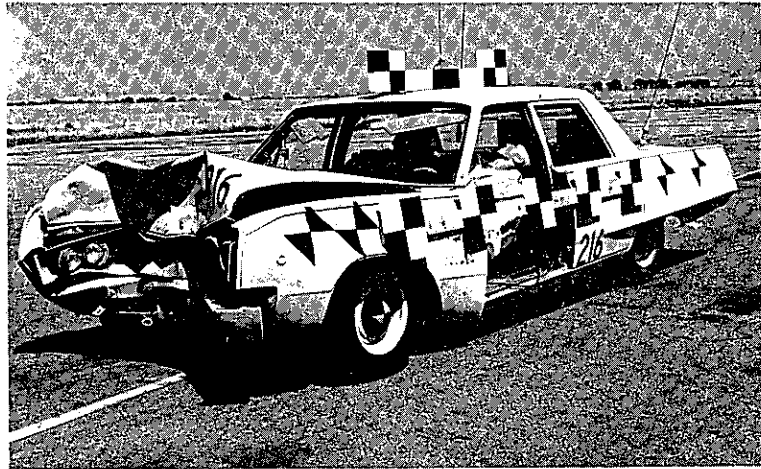
Figure 26

The maximum crush of the vehicle forestructure was 20 inches and occurred at the center of the vehicle (see Exhibit 8 and Figure 26, below). Buckling of the car body was indicated by a crimp in the roof over the door post on both sides of the car. The engine deflected the metal firewall back 1-2 inches. Steering wheel deformation was 1-1/4 inches. The steering column collapsed 2.9 inches. (There were collapsible steering

columns in the 1968 Dodges used for Tests 215 through 218; however, there was no measurable collapse of them except in the vehicle used for this test).

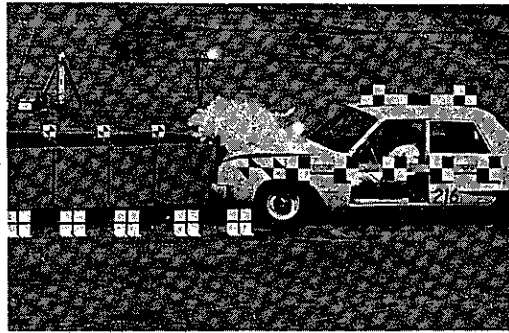
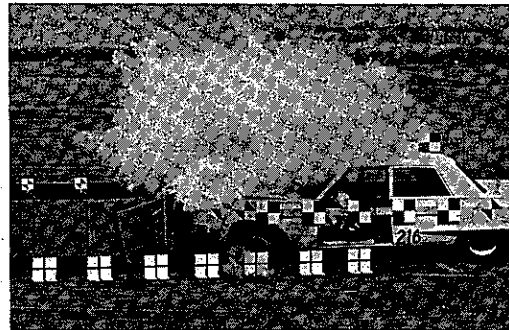
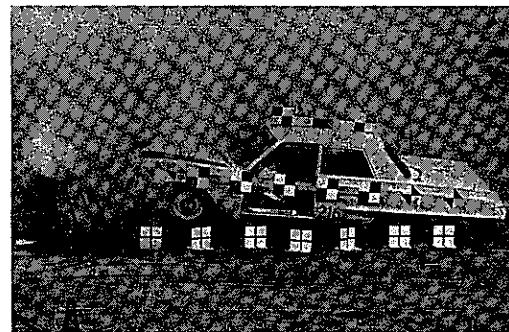
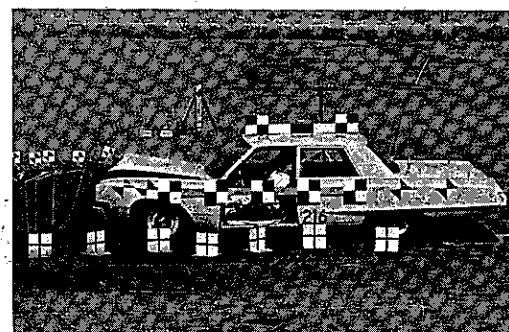
PLATE 7

Results: Plate 7, page 35, contains a summary of the test results. A 4690 lb. 1968 Dodge impacted the barrier headon at a speed of 61.8 mph. Deceleration of the impacting vehicle was relatively smooth and the vehicle remained stable. Vehicle rise was a little more than 1'.

No barrier components were dislodged. Fender panels on the left side of the first three modules were scarred. Bottoms and/or top inserts were blown out of 16 water cells. The shear pins on the front secondary cables were sheared off. The barrier as a whole was translated straight back with negligible lateral movement or "buckling". Maximum vehicular displacement of the barrier was 16.3 feet but the permanent displacement of the barrier nose was only 10.7 feet (see Figure 27, below).

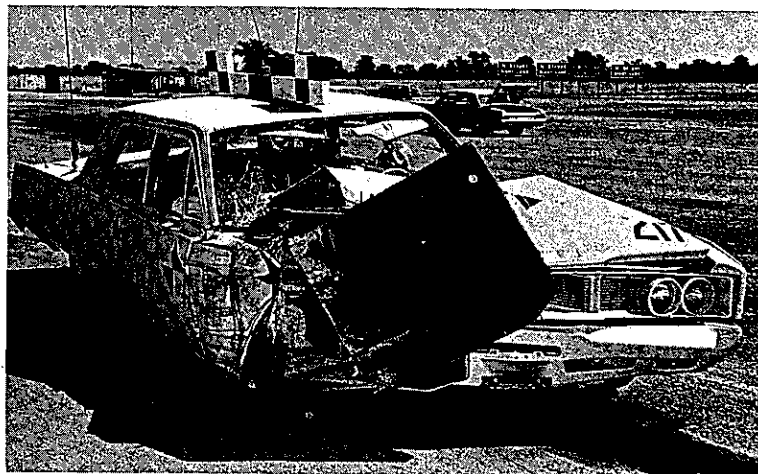
Figure 28

Results: Plate 8, page 39, contains a summary of the test results. A 4760 lb. 1968 Dodge impacted along the side of the barrier ten feet behind the barrier nose at a speed of 57.0 mph and an angle of 9°. After the vehicle struck the barrier, it was slightly redirected by the barrier fender panels. However, significant redirection was not achieved until the solid resistance of the bridge approach guardrail was utilized. There was virtually no rise of the vehicle forestructure. The right front side of the car was severely crushed; there was no crush on the left side. (See Figure 28, below, and Exhibit 8). The right front door was damaged and jammed and the right door post was partially torn loose at the roof connection. The right side of the hood cracked the windshield. Near the end of the collision, the right rear quarter panel of the car slapped the barrier. This damaged the right rear fender and the right end of the rear bumper. A crimp in the roof over the door posts was sustained on both sides of the car; the radiator was buckled back toward the engine on the right side. The steering wheel had a slight deformation but the steering column did not collapse.

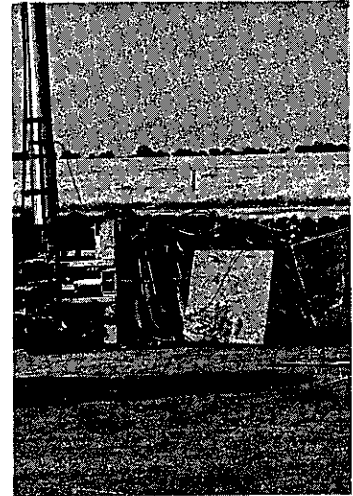
Figure 30

Several fender panels were torn off the barrier on the left side, mainly due to hinge failures. Two panels were thrown 8'-0" beyond the final position of the car and two panels were lodged in the crushed front end of the car. The five cells on the left side

of the bridge approach guardrail were all torn off and scattered along the path of the car. Shear pins in the secondary cables sheared off. Permanent displacement of the barrier nose was 1.5 feet (see Figures 29 and 30, below).

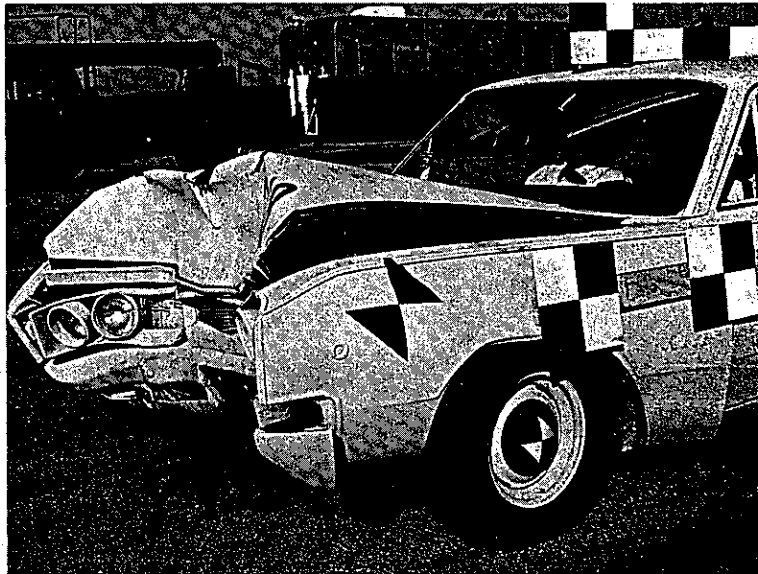
Figure 31

Results: Plate 9, page 43, contains a summary of the test results. A 4760 lb. 1968 Dodge impacted the nose of the barrier at an angle of 8° and a speed of 59.2 mph. The vehicle struck the barrier, rotated until it was nearly on line with the barrier axis, and continued to a stop in a manner similar to that of Test 216 (62 mph headon impact). The crush in the vehicle forestructure formed an arc (plan view) with least crush at the fenders. Maximum crush at the center was 19 inches (see Figure 31, below, and Exhibit 8). Once again, a crimp was noted in the roof over the door posts on both sides of the car. The left front door was jammed and the radiator buckled back towards the engine. Vehicle rise was 1'-4".
